Footprints Property Inspections, LLC

Client(s): John Smith and Susan Smith
Property address: 999 S. Some house Rd.
Copley Twp., OH 44321
Inspection date: Thursday, September 11, 2014

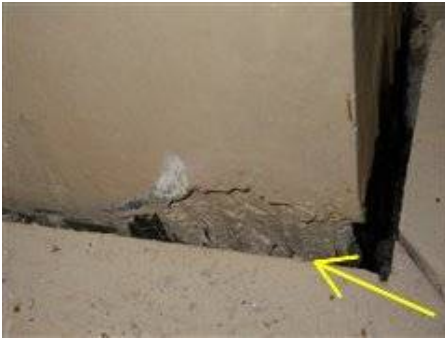
- Fungal rot was found in support posts at one or more structures covering decks, patios and/or porches. Recommend that a qualified person repair as necessary. All rotten wood should be replaced.

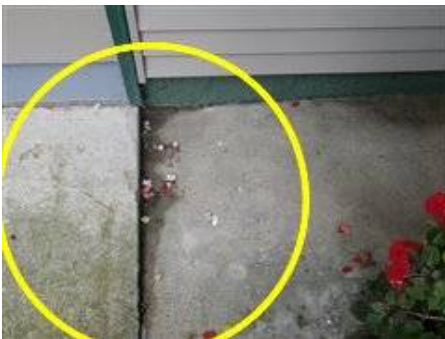
- The driveway sloped down towards the garage or house. Based on observations made during the inspection, significant amounts of water appear to have accumulated around building foundations or under buildings as a result. This is a conducive condition for wood-destroying organisms. Recommend that a qualified contractor evaluate and repair as necessary. For example, by installing drain(s) or removing and installing new pavement.

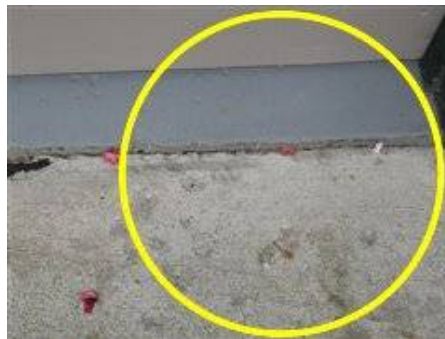
Concrete has dropped and recommend sealing and adding vinyl concrete patch with slope away from house.

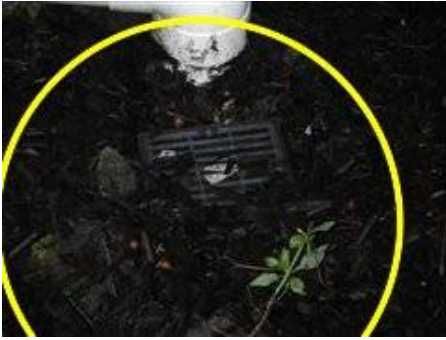
nuisance, or may flow towards the building. Recommend that a qualified person clear drains as necessary.

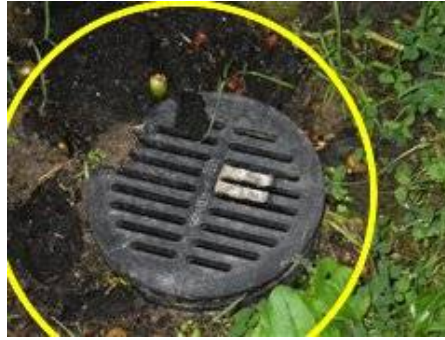
Grate to close to foundation and is allowing water to pool next to foundation where water appears to be coming in basement.

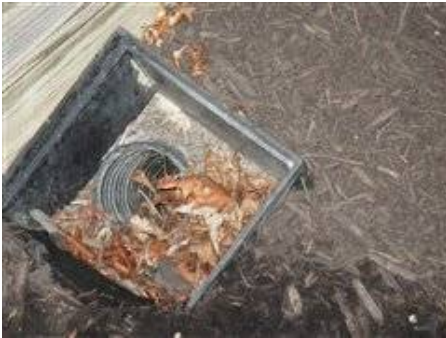
Drain grate is set high to soil around - grading and sloping away from foundation is need all along north end of house to prevent water intrusion.

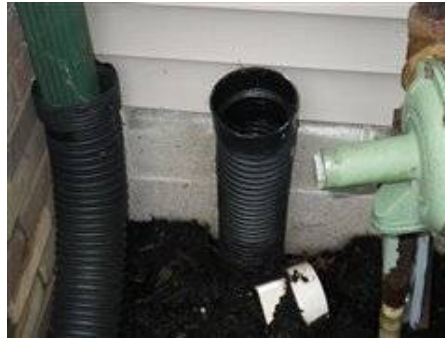
Missing grate cover and is sitting to high.

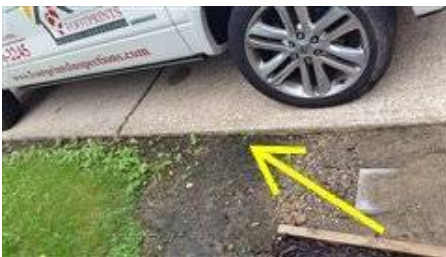
Open drain without grate cover but unable to tell need or use for it? Could clogged other lines if not capped.

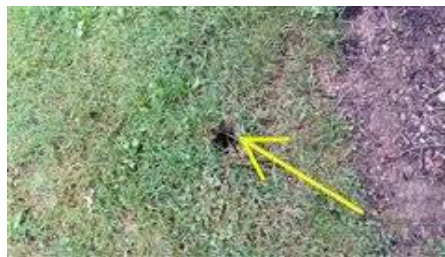
Grading along driveway being washed away due to downspouts empty against. This will erode soil under and allow shoving and heaving which will damage concrete driveway. Relocation of downspout needs done soon.

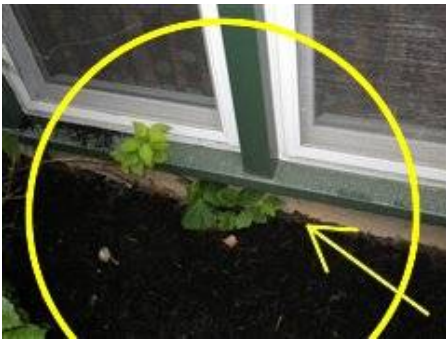
Photo 7-1
Soil and mulch against wood framing under window. Recommended to be min. 6" below.

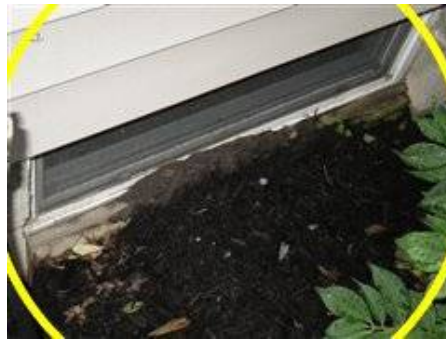
Photo 7-2
Soil and mulch against window ledge and wood framing. Recommend keeping soil min. 6" away.

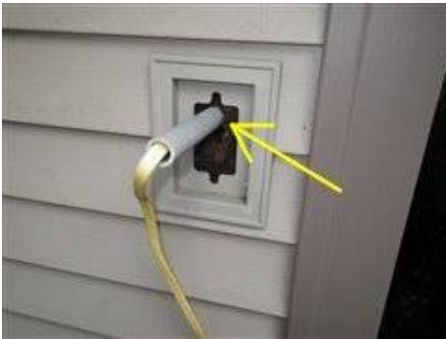
Photo 8-1
Gap around plastic conduit needs sealed or caulked.

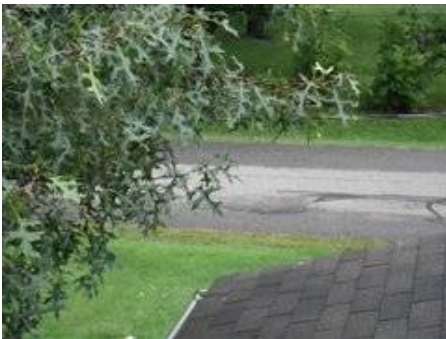
Photo 9-1
Trees overhanging roof -recommend a tree arborist trim back off roof line to prevent wood destroying insects.

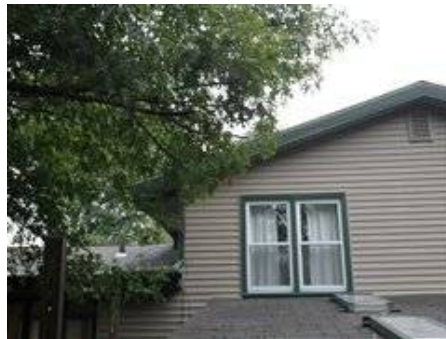
Photo 9-2
Trees overhanging roof lines - recommend trimming back to prevent wood destroying insects damage.

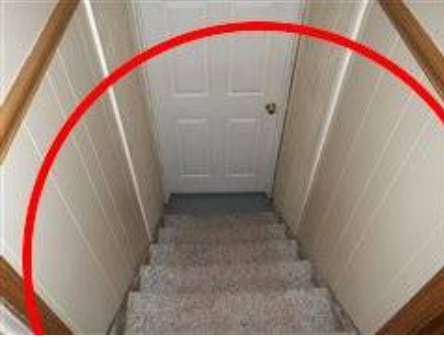
with four or more risers or where stairs are greater than 30 inches high. Recommend that a qualified contractor install handrails where missing and per standard building practices.

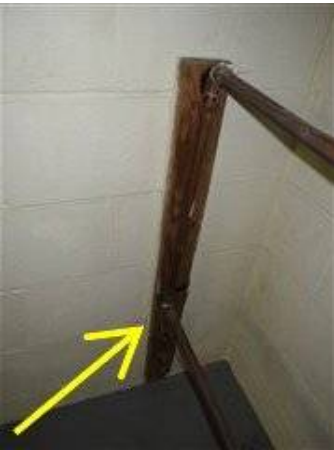
Ideally, water should not enter basements, but if water must be controlled after it enters the basement, then typical repairs include installing a sump pump.

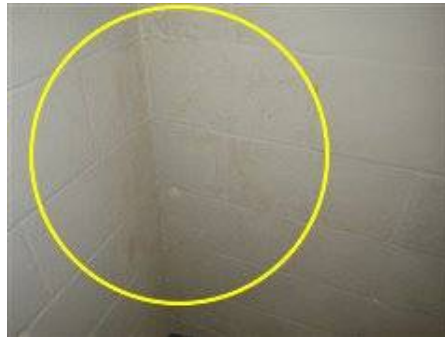
Main water supply pipe is longer than needed and water is intruding in where mounted on wall. Recommend cutting back and filling holes with a product like UGL's Fast Plug.

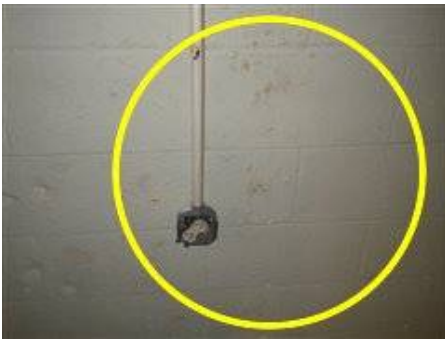
Efflorescence in basement NE corner - show signs of previous moisture issues.

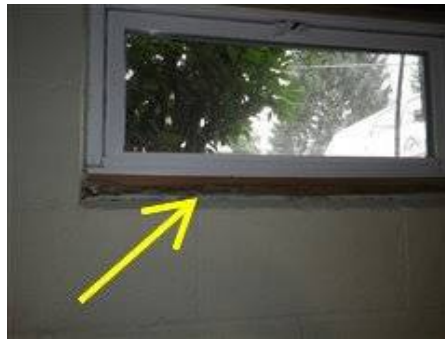
Efflorescence on block wall but recently painted.

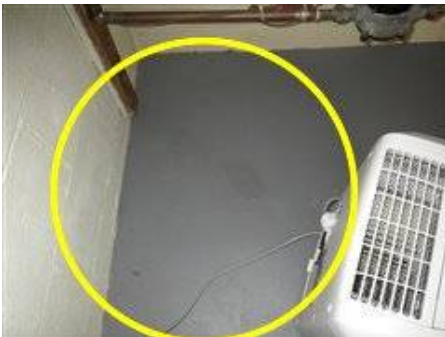
Ideally, water should not enter basements, but if water must be controlled after it enters the basement, then typical repairs include installing a sump pump.

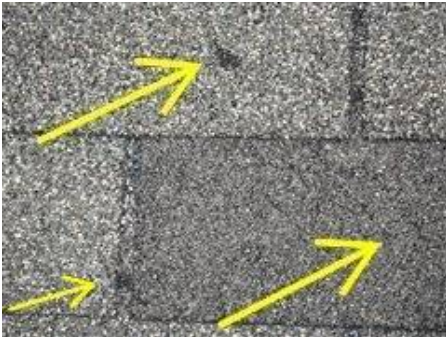
Photo 15-1
Missing granules on a few shingle tabs - monitor or seal.

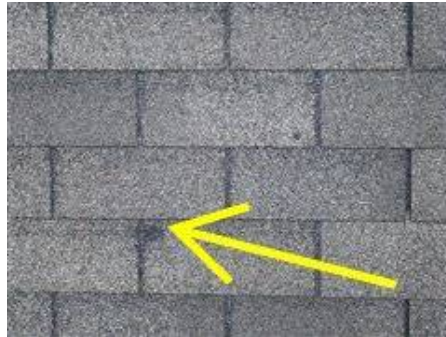
Photo 15-2
#2 Missing granules on a few shingle tabs - monitor or seal.

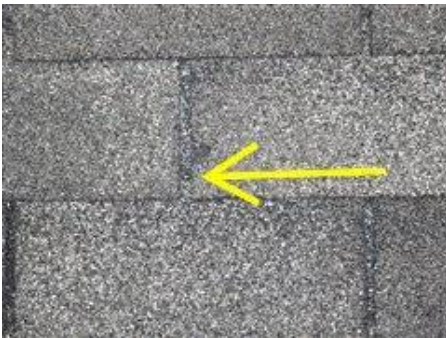
Photo 15-3
#3 Missing granules on a few shingle tabs - monitor or seal.

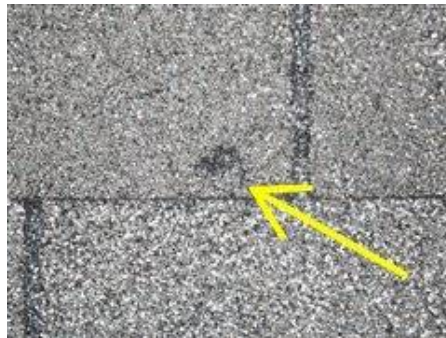
Photo 15-4
#4 Missing granules on a few shingle tabs - monitor or seal.

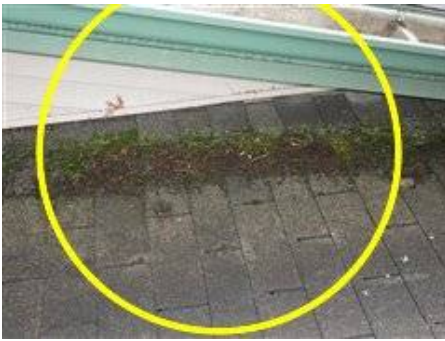
<http://www.reporthost.com/?MOSS>

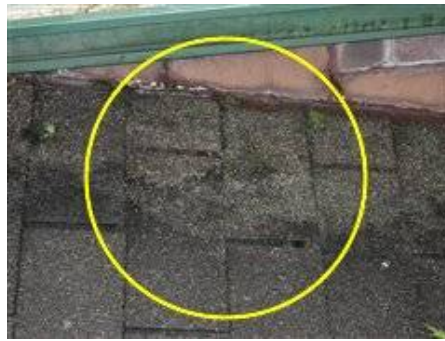
Moss growth on roofing shingles - recommend cleaning off to prevent shingle life cycle shortened.

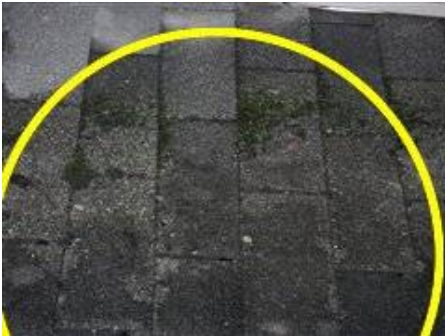
Moss growth on roofing shingles.

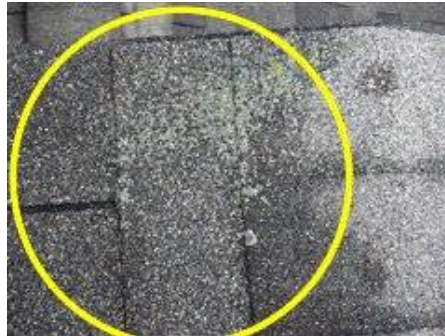
Moss growth on roofing shingle near 2nd story roof overhangs. Recommend cleaning off.

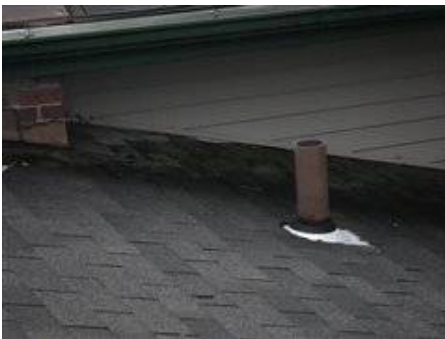
Moss growth on shingles that is recommended to clean off.

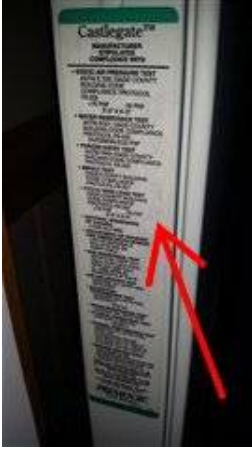
Photo 18-1
Non-fire rated garage - house entrance door.

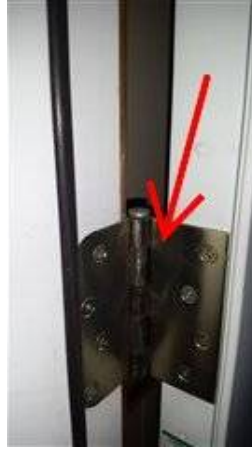
Photo 18-2
Non spring loaded hinge to help aide in metal door fire rating. Recommend adding a spring loaded hinge.

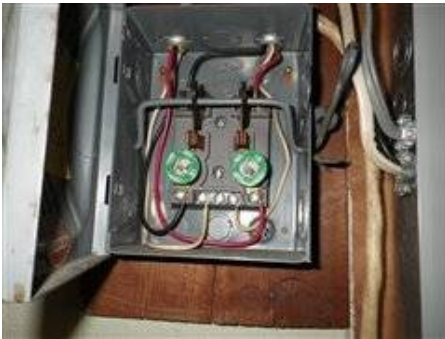
Photo 20-1
Two 30amp fuses for dryer service. Recommend replace to a breaker sub panel or replacing main panel with an upgraded 150 amp service panel to eliminate.

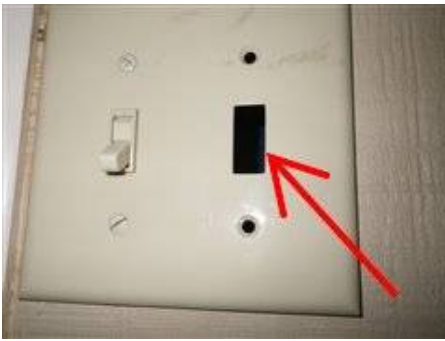
- Substandard wiring was found at the basement. For example, missing or broken cover plates. This is a safety hazard. Recommend that a qualified electrician evaluate and repair as necessary and per standard building practices.

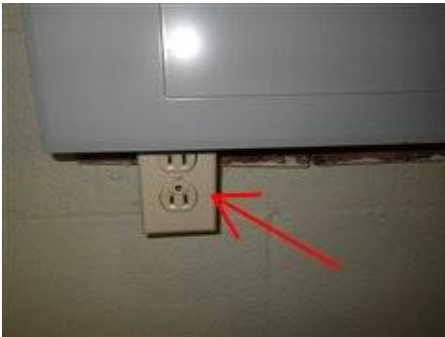
<http://www.reporthost.com/?GFCI>

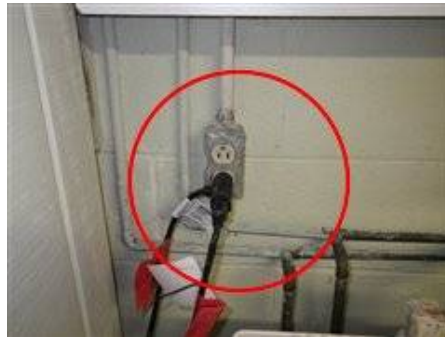
No GFCI outlet at service panel as now recommended.

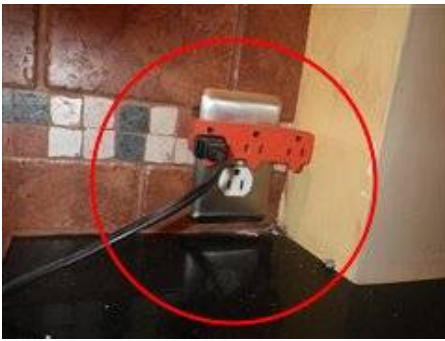
Photo 22-3
Outlet by sink needs to be replaced with a GFCI outlet.

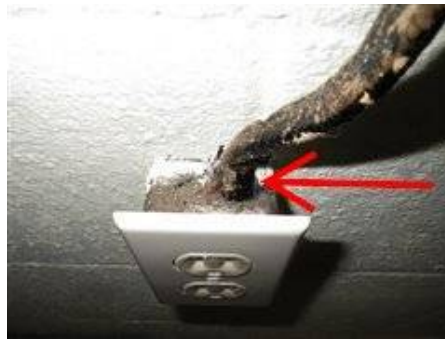
Photo 22-4
Improper connection as wire connector is not used and wire is loosely hanging on wall. Unsafe condition

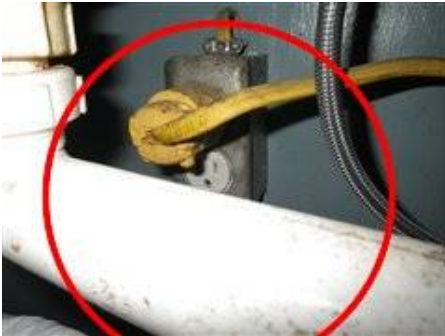
Photo 22-5
Food disposal outlet is a non GFCI outlet as recommended. Have a licensed electrician repair all electrical issues.

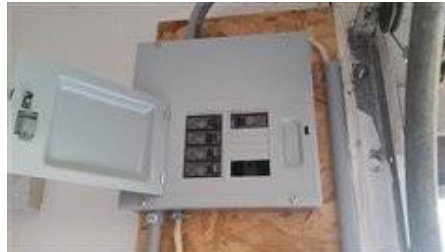
Photo 22-6
Additional service panel with breakers in garage.

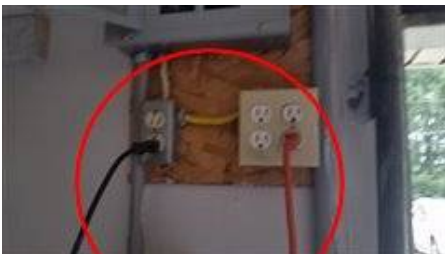
Photo 22-7
Outlets in garage are non GFCI outlets as now recommended.

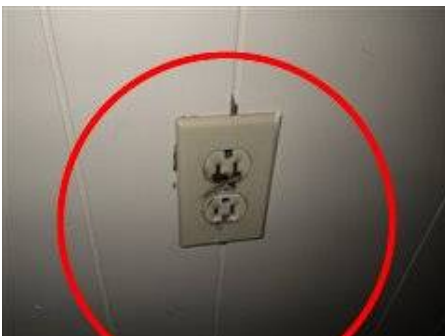
23 🔧 🔍 - One or more wall switches were scorched. The wiring for these switches may be damaged due to overheating. Recommend that a qualified electrician replace such switches, evaluate related wiring and repair if necessary.

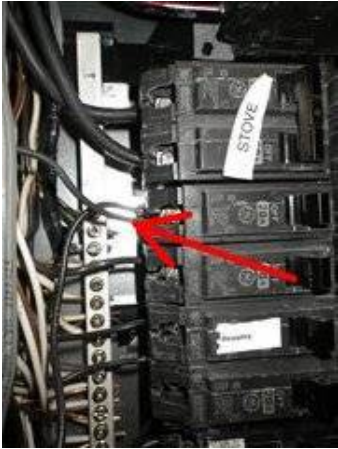
Photo 24-1
Double tap in service breaker panel.
Safety hazard

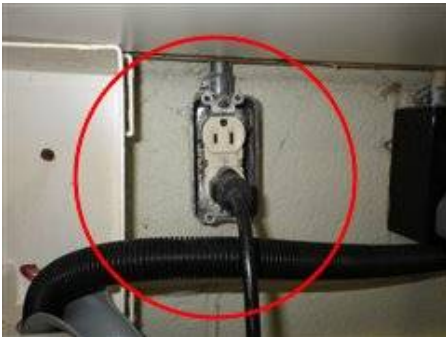
Photo 25-1
Missing cover plate - unsafe condition.

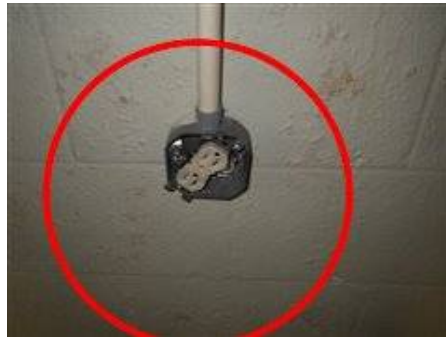
Photo 25-2
Missing cover plate - unsafe condition.

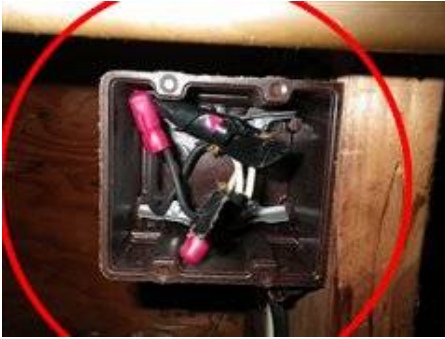
Photo 25-5
Cover plate is missing.

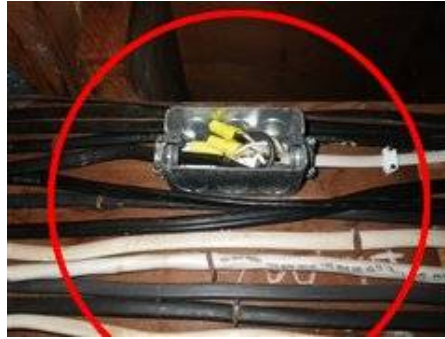
Photo 25-6
Cover plate is missing.

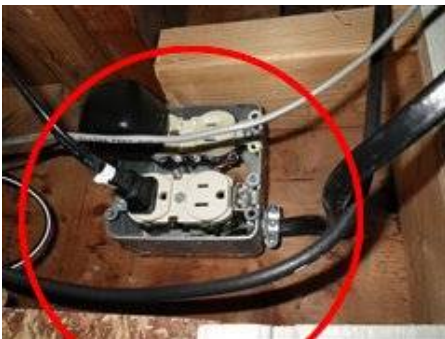
Photo 25-7
More unsafe conditions from missing plate covers

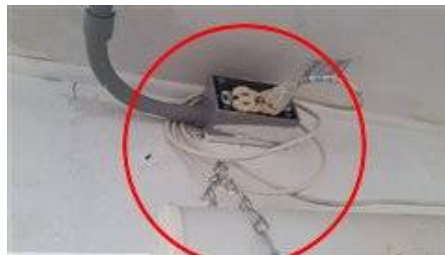
Photo 25-8
Cover plate missing in garage. Safety hazard

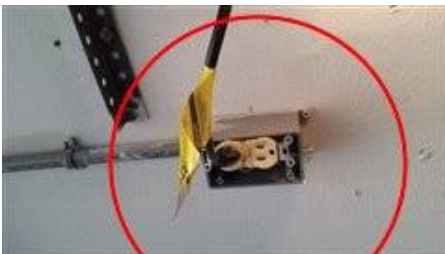
Photo 25-9
Cover plate missing in garage. Safety hazard

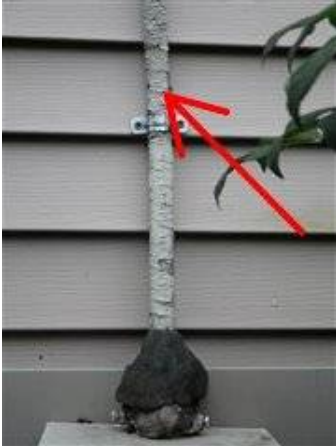
- Main electrical service feed should be evaluated by First Energy on replacement of weathered feed line.

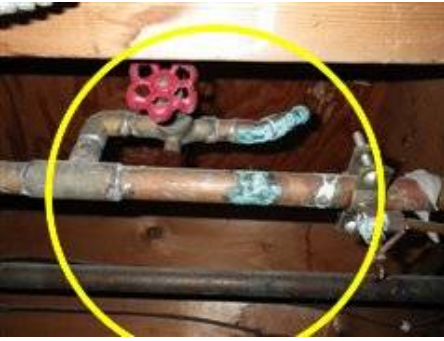
- Pin holes and/or corrosion were visible on one or more copper water supply pipes. This can occur with acidic water, and from flux applied at fittings for soldering when the pipes were installed or repaired. Leaks can occur from pinholes and corrosion usually indicates past leaks. Recommend consulting with the local municipality and/or a qualified plumber about the local water supply's pH level, and researching solutions for this if necessary. Also recommend that a qualified plumber evaluate and replace water supply components if necessary.

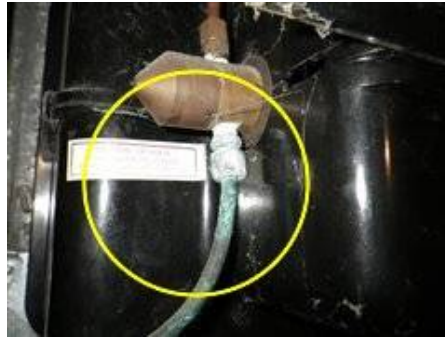
Corrosion found on plumbing pipe that appears to not be used and is capped off. Monitor for possible future leakage.

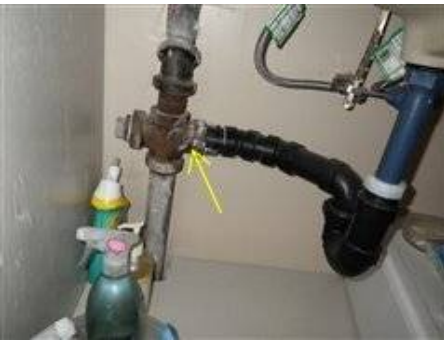
Humidifier line is corrosion and is in non-working order. Recommend line replacement and evaluate by HVAC tech. when servicing furnace.

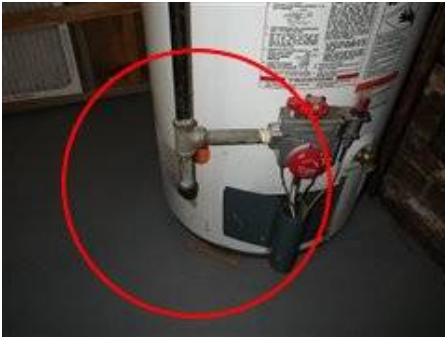
Water heater shut offs locations when needed.

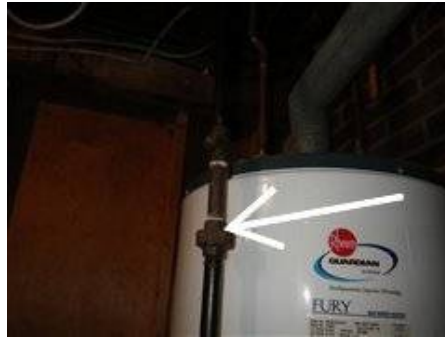
Galvanized piping used in place of approved black gas piping. Safety concerns and should be replaced.

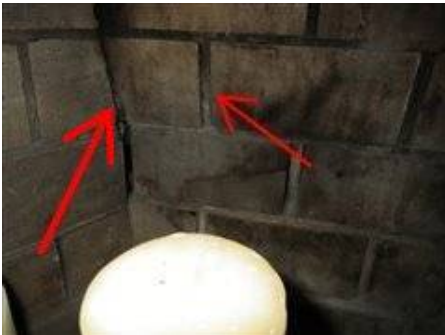
- The fireplace's firebox was significantly deteriorated. For example, loose, cracked, pitted or broken firebricks, gaps between bricks and/or missing mortar. Heat from the fireplace may penetrate the firebox. This is a potential fire hazard. Recommend that a qualified contractor repair as necessary.

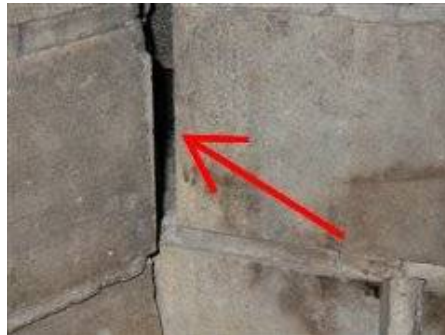
Wood burning fireplace has defective fire bricks with gaps. Fire brick lining needs tucked.

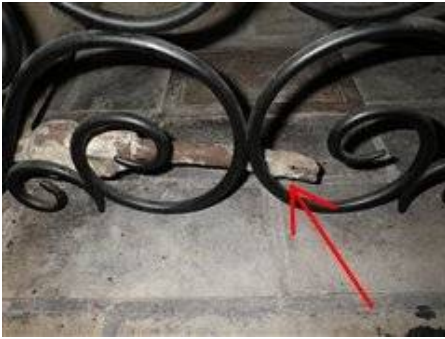
Photo 40-3
Gas starter need stem replacement due to corrosion.

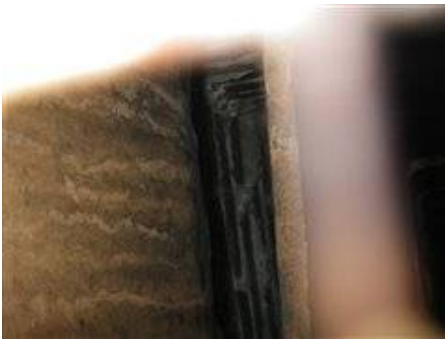
Photo 41-1
Clay flue liner in chimney is offset and needs evaluated by a qualified masonry contractor with chimney repair work.

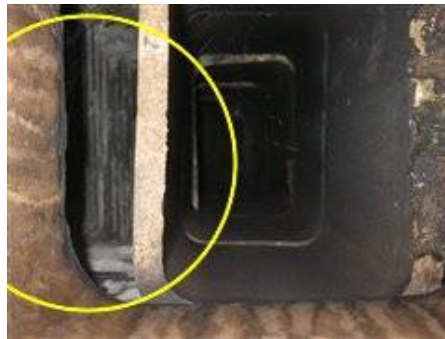
Photo 41-2
Clay flue liner in chimney is offset and needs evaluated by a qualified masonry contractor with chimney repair work.

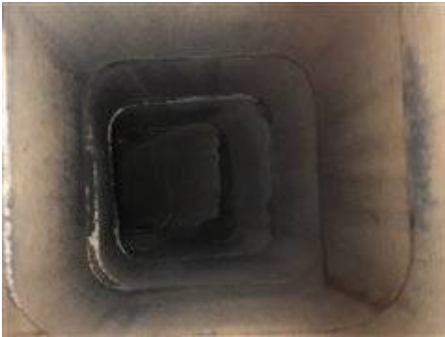
Photo 41-3
Second chimney flue appears to be okay.

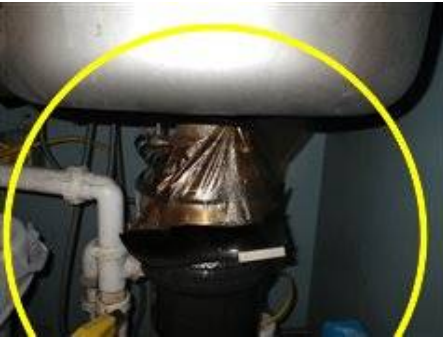
- The under-sink food disposal was significantly corroded. Recommend that a qualified contractor repair or replace as necessary.

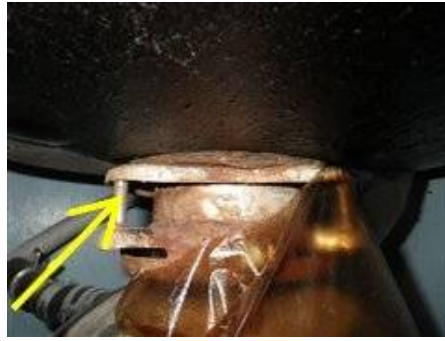
Garbage disposal is improperly sealed and shows previous leakage. See plastic tapped to mounting hardware.

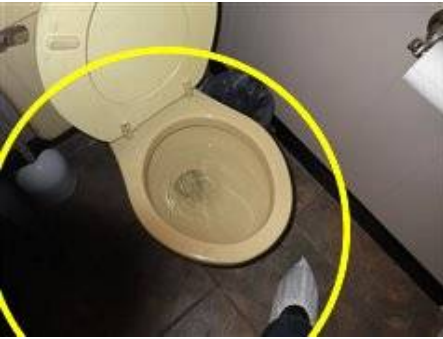
44 🔧🔍 - The toilet at location(s) #A was loose where it attached to the floor. Leaks can occur. Flooring, the sub-floor or areas below may get damaged. Sewer gases can enter living spaces. Recommend that a qualified contractor remove the toilet(s) for further evaluation and repair if necessary. A new wax ring should be installed and toilet(s) should be securely anchored to the floor to prevent movement and leaking.

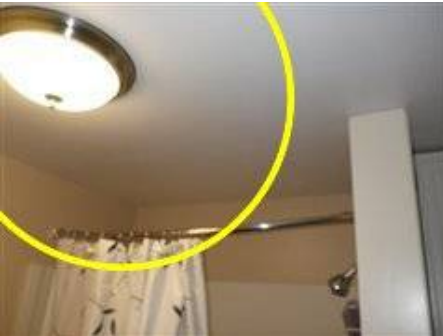
45 🔧 - The bathroom with a shower or bathtub at location(s) #B didn't have an exhaust fan installed. Moisture can accumulate and result in mold, bacteria or fungal growth. Even if the bathroom has a window that opens, it may not provide adequate ventilation, especially during cold weather when windows are closed or when wind blows air into the bathroom. Recommend that a qualified contractor install exhaust fans per standard building practices where missing in bathrooms with showers or bathtubs.

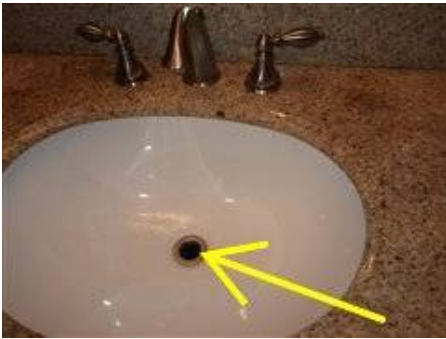
Photo 46-1
Stopper missing in sink

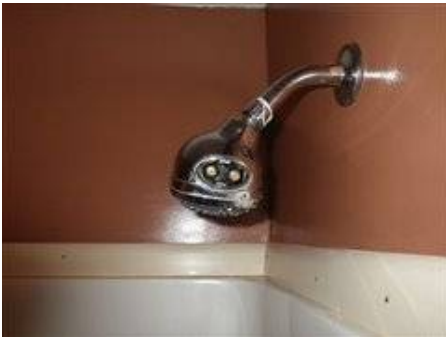
Photo 48-1
Shower head missing cover plate.

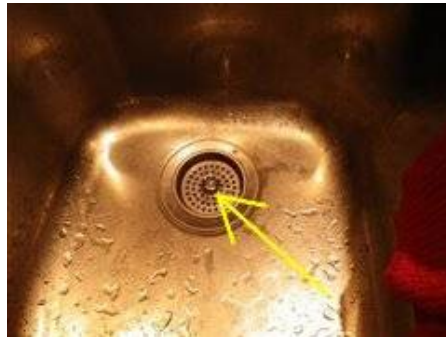
Photo 48-2
Sink stopper is defective and doesn't seem to hold water when tested.

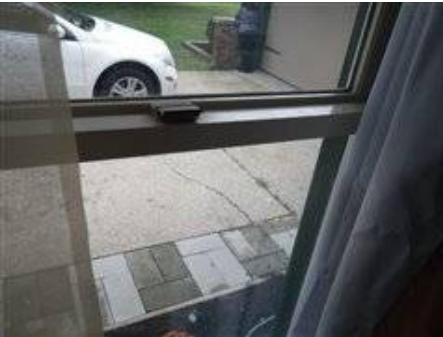
- One or more windows that were designed to open and close were stuck shut. Recommend that a qualified person repair windows as necessary so they open and close easily.

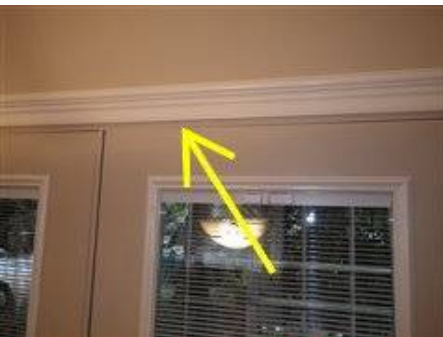
- Patio door needs aligned properly. Adjustment probably with use of longer screws.

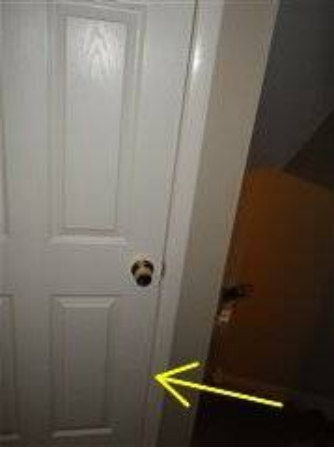
Also a couple of the doors needed bottoms trimmed off to prevent carpet damage.

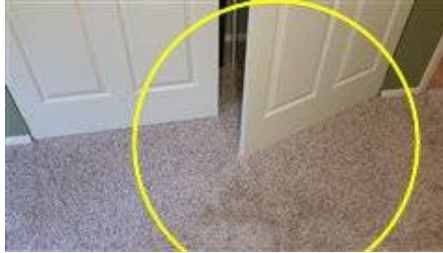
Door needs side shaved or sanded as it stick in frame.

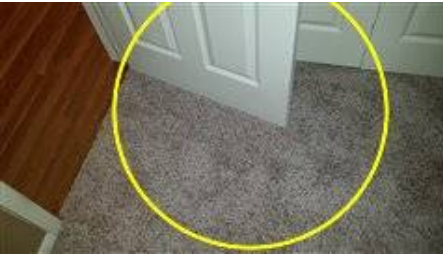
Doors drag on newer carpet and recommend trimming down to prevent damage to carpet.

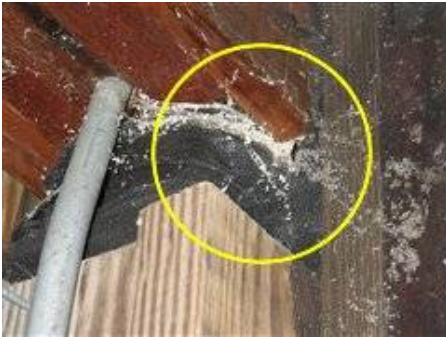
Photo 55-1
Carpenter ant evidence on decorative center beam - recommend treatment for both carpenter bees and carpenter ants.

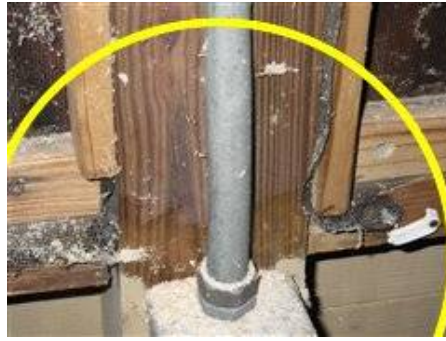
Photo 55-2
Wood destroying insect damage evidence.

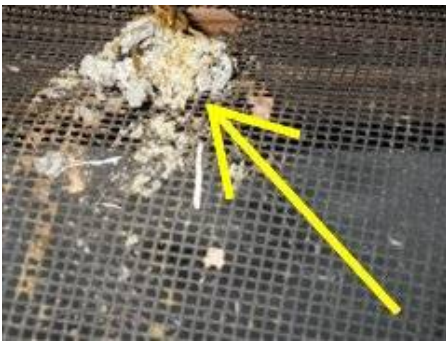
Photo 56-1
Evidence of wood destroying Carpenter bees on patio privacy wall/screening.

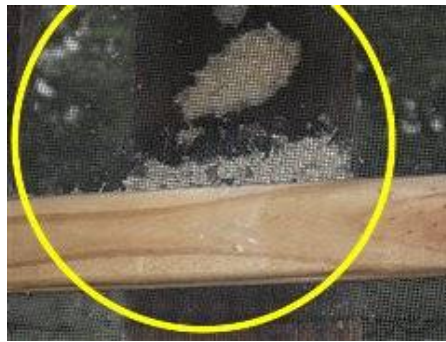
Photo 56-2
Evidence of carpenter bee damage. Recommend plugging holes with a butyl caulk to prevent reuse next season.

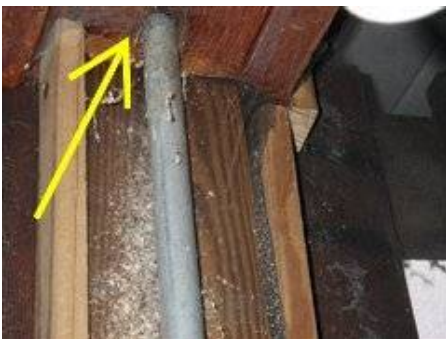
Photo 56-3
Wood destroying insect damage evidence.

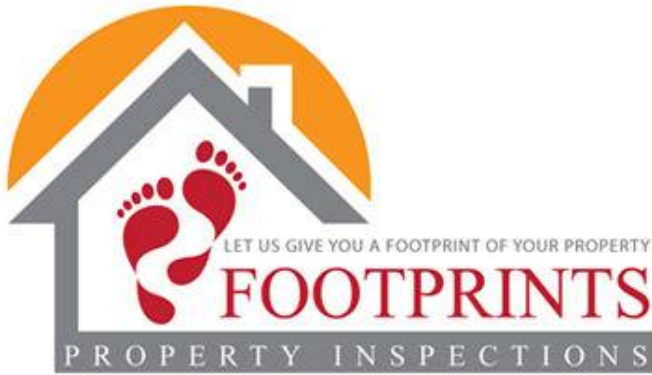
Footprints Property Inspections, LLC

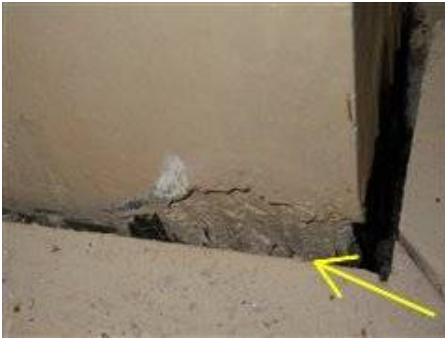
Fungal rot was found in support posts at one or more structures covering decks, patios and/or porches. Recommend that a qualified person repair as necessary. All rotten wood should be replaced.

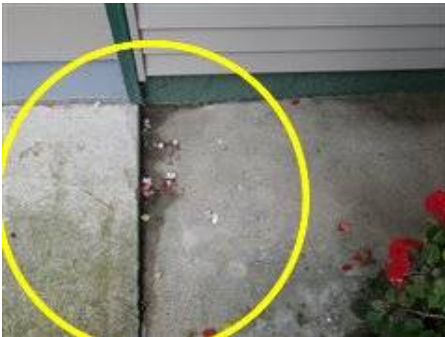
The driveway sloped down towards the garage or house. Based on observations made during the inspection, significant amounts of water appear to have accumulated around building foundations or under buildings as a result. This is a conducive condition for wood-destroying organisms. Recommend that a qualified contractor evaluate and repair as necessary. For example, by installing drain(s) or removing and installing new pavement.

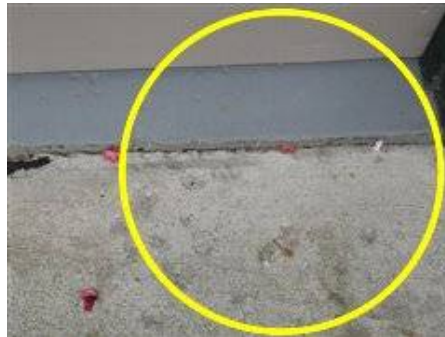
Concrete has dropped and recommend sealing and adding vinyl concrete patch with slope away from house.

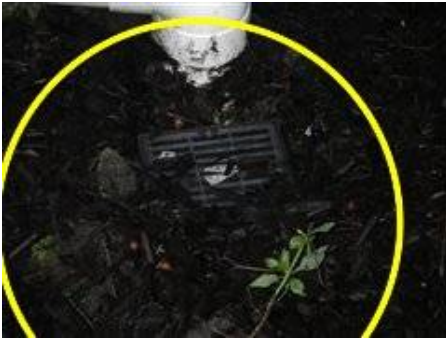
Photo 5-1
Grate to close to foundation and is allowing water to pool next to foundation where water appears to be coming in basement.

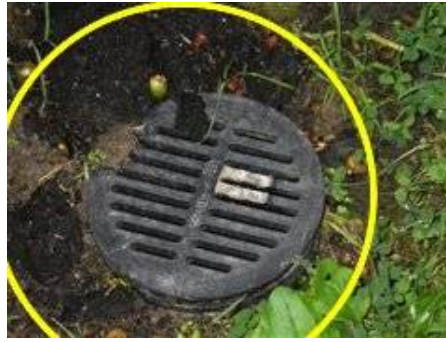
Photo 5-2
Drain grate is set to high to soil around - grading and sloping away from foundation is need all along north end of house to prevent water intrusion.

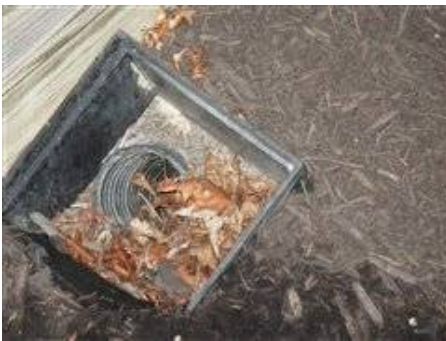
Photo 5-3
Missing grate cover and is sitting to high.

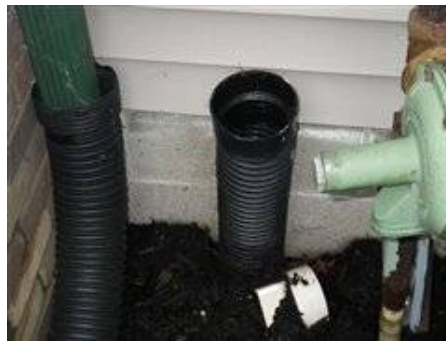
Photo 5-4
Open drain without grate cover but unable to tell need or use for it? Could clogged other lines if not capped.

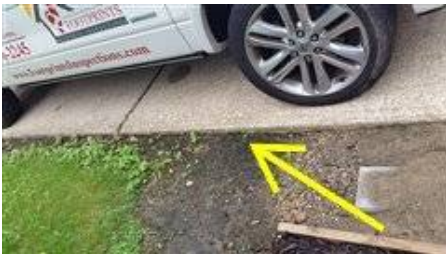
Photo 5-5
Grading along driveway being washed away due to downspouts empty against. This will erode soil under and allow shoving and heaving which will damage concrete driveway. Relocation of downspout needs done soon.

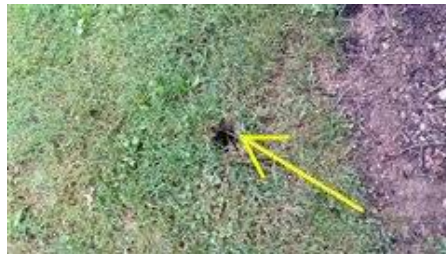
Photo 5-6
Open drain without grate cover. evaluate drain system and need.

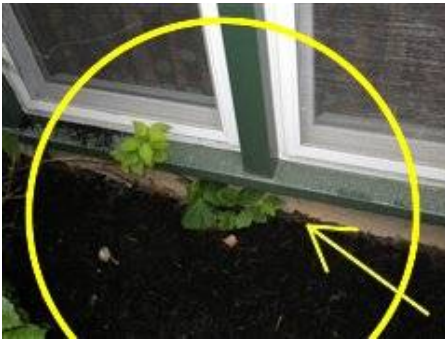
Soil was in contact with or less than 6 inches from siding, trim or structural wood. This is a conducive condition for wood-destroying organisms. Recommend grading or removing soil as necessary to maintain a 6-inch clearance. If not possible, then recommend replacing untreated wood with pressure-treated wood. Installation of borate-based products such as Impel rods can also reduce the likelihood of rot or infestation if soil cannot be removed. Note that damage from fungal rot and/or insects may be found when soil is removed, and repairs may be necessary.

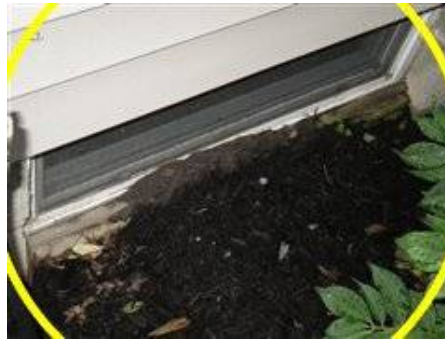
Soil and mulch against wood framing under window. Recommended to be min. 6" below.

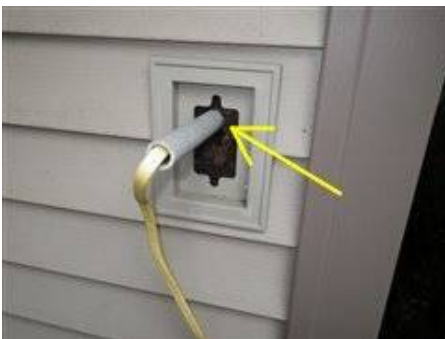
One or more holes or gaps were found in siding or trim. Vermin, insects or water may enter the structure. Recommend that a qualified person repair as necessary.

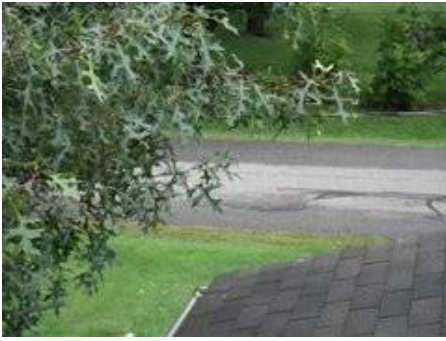
Trees were in contact with or were close to the building at one or more locations. Damage to the building can occur, especially during high winds, or may have already occurred (see other comments in this report). Recommend that a qualified tree service contractor or certified arborist remove trees as necessary to prevent damage to the building exterior.

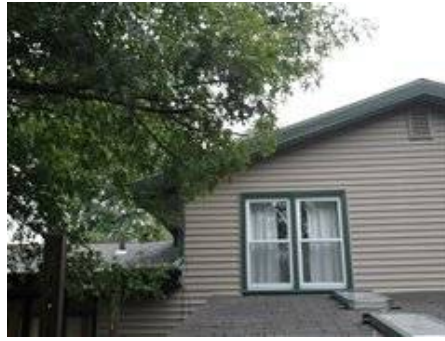
Trees overhanging roof -recommend a tree arborist trim back off roof line to prevent wood destroying insects.

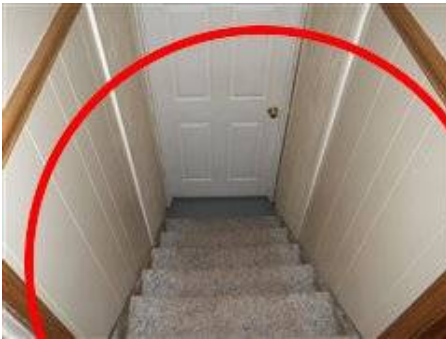
Handrails at one or more flights of stairs were missing. This is a potential fall hazard. Handrails should be installed at stairs with four or more risers or where stairs are greater than 30 inches high. Recommend that a qualified contractor install handrails where missing and per standard building practices.

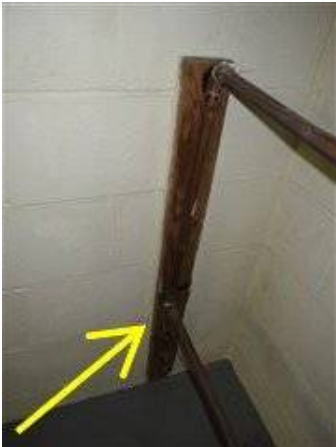
Ideally, water should not enter basements, but if water must be controlled after it enters the basement, then typical repairs include installing a sump pump.

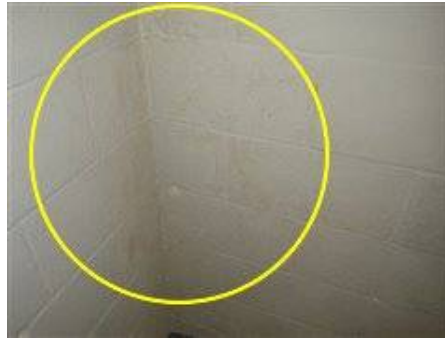
Main water supply pipe is longer than needed and water is intruding in where mounted on wall. Recommend cutting back and filling holes with a product like UGL's Fast Plug.

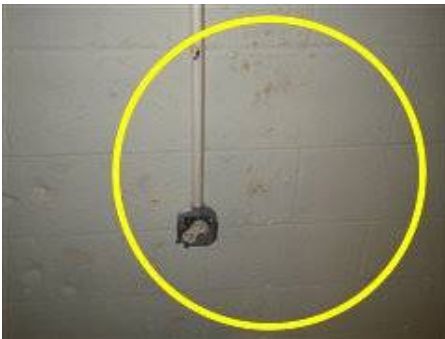
Efflorescence in basement NE corner - show signs of previous moisture issues.

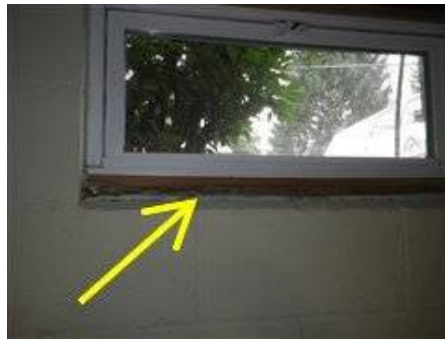
Efflorescence on block wall but recently painted.

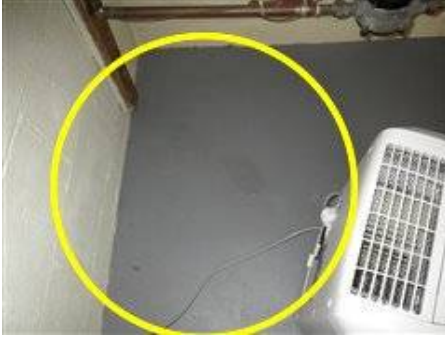
Ideally, water should not enter basements, but if water must be controlled after it enters the basement, then typical repairs include installing a sump pump.

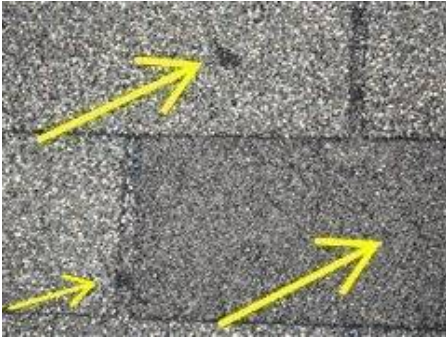
Photo 15-1
Missing granules on a few shingle tabs - monitor or seal.

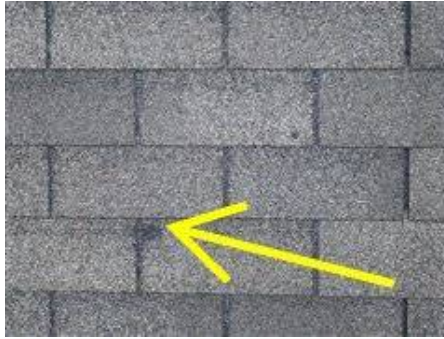
Photo 15-2
#2 Missing granules on a few shingle tabs - monitor or seal.

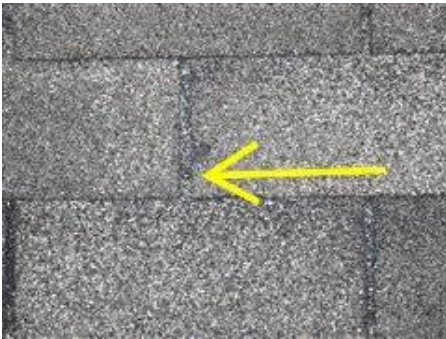
Photo 15-3
#3 Missing granules on a few shingle tabs - monitor or seal.

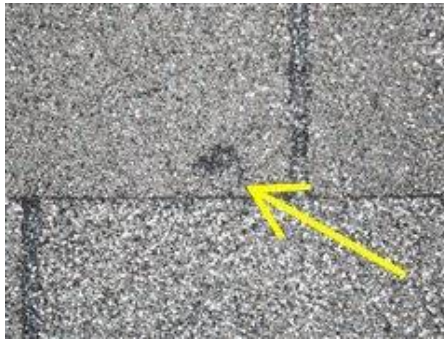
Photo 15-4
#4 Missing granules on a few shingle tabs - monitor or seal.

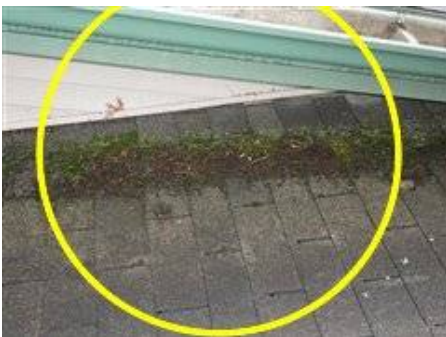
Photo 16-1
Moss growth on roofing shingles - recommend cleaning off to prevent shingle life cycle shortened.

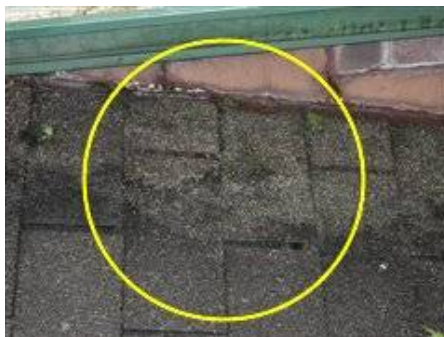
Photo 16-2
Moss growth on roofing shingles.

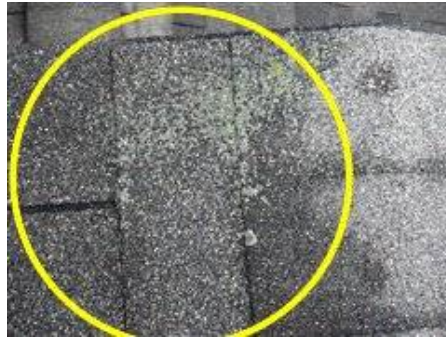
Moss growth on roofing shingle near 2nd story roof overhangs. Recommend cleaning off.

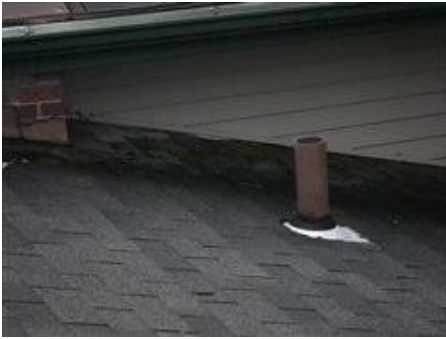
Moss growth on shingles that is recommended to clean off.

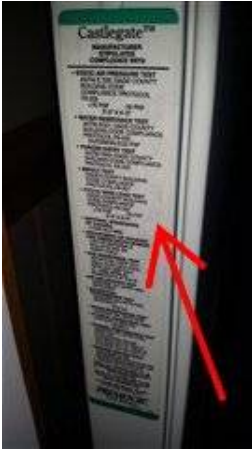
<http://www.reporthost.com/?AGFR>

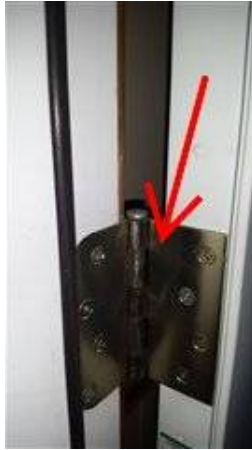
Non-fire rated garage - house entrance door.

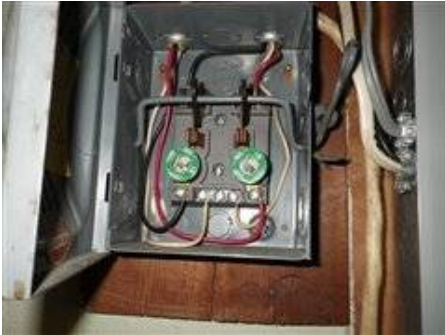
Panel(s) #B used screw-in fuses for the over-current protection devices. Fuses are prone to tampering and over-fusing, which can damage wiring and cause fire hazards. Insurance companies may deny coverage for homes with fused panels. Modern panels use circuit breakers for over-current protection devices, which can be reset easily after tripping rather than needing to replace fuses. Modern panels also offer more flexibility for new, safer protective technologies like ground fault circuit interrupters (GFCIs) and arc fault circuit interrupters (AFCIs). Consult with a qualified electrician about replacement options for fused panels, and about other system upgrades as necessary.

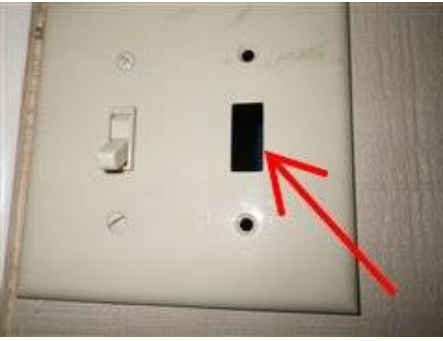
Substandard wiring was found at the basement. For example, missing or broken cover plates. This is a safety hazard. Recommend that a qualified electrician evaluate and repair as necessary and per standard building practices.

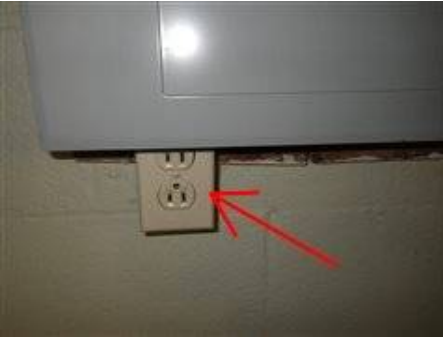
<http://www.reporthost.com/?GFCI>

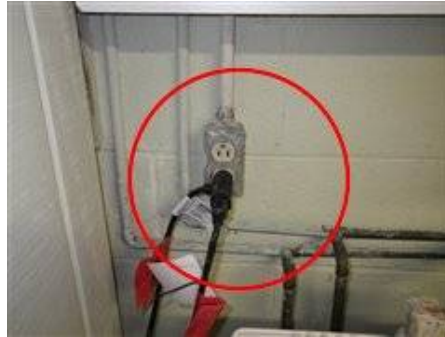
No GFCI outlet at service panel as now recommended.

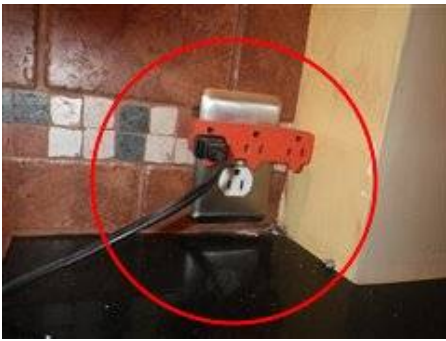
Photo 22-3
Outlet by sink needs to be replaced with a GFCI outlet.

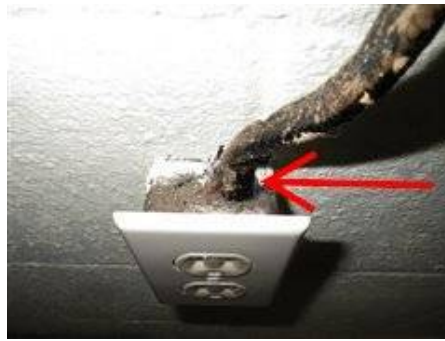
Photo 22-4
Improper connection as wire connector is not used and wire is loosely hanging on wall. Unsafe condition

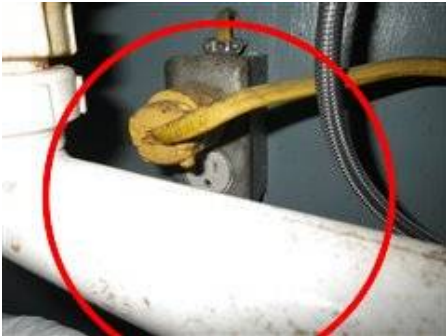
Photo 22-5
Food disposal outlet is a non GFCI outlet as recommended. Have a licensed electrician repair all electrical issues.

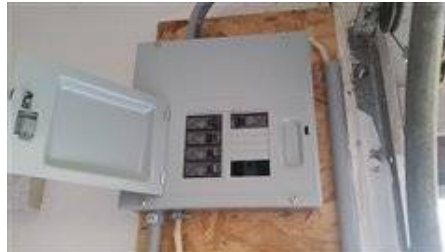
Photo 22-6
Additional service panel with breakers in garage.

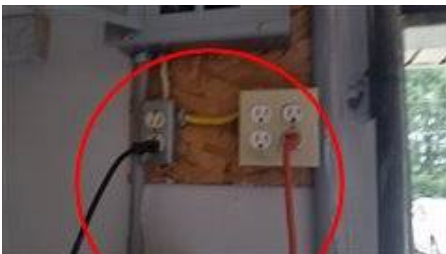
Photo 22-7
Outlets in garage are non GFCI outlets as now recommended.

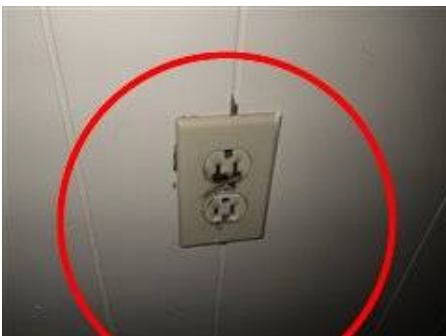
One or more wall switches were scorched. The wiring for these switches may be damaged due to overheating. Recommend that a qualified electrician replace such switches, evaluate related wiring and repair if necessary.

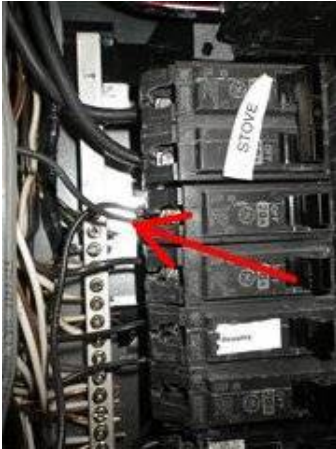
Photo 24-1
Double tap in service breaker panel.
Safety hazard

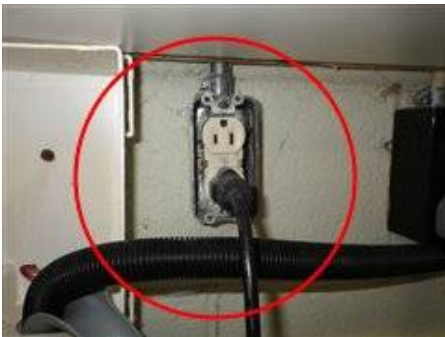
Photo 25-1
Missing cover plate - unsafe condition.

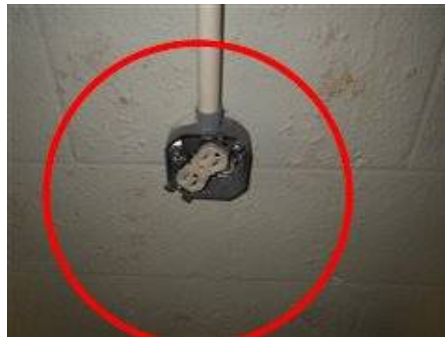
Photo 25-2
Missing cover plate - unsafe condition.

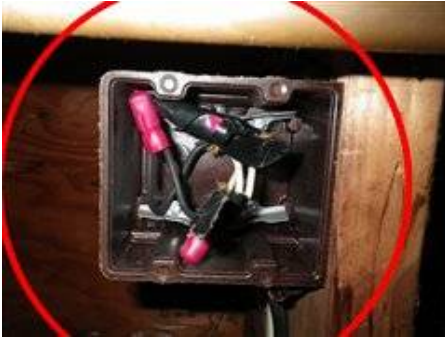
Photo 25-5
Cover plate is missing.

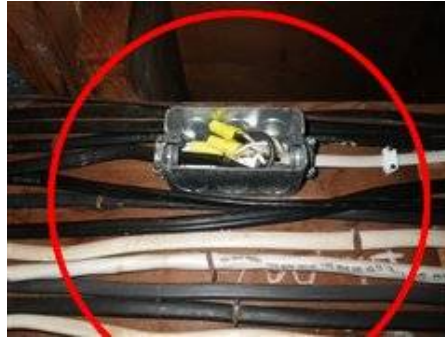
Photo 25-6
Cover plate is missing.

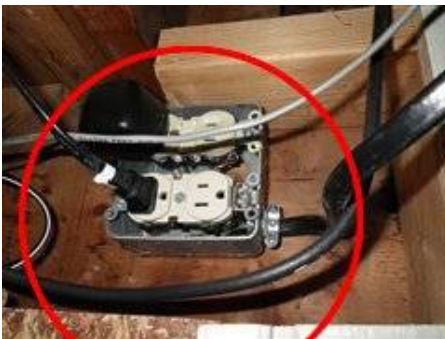
Photo 25-7
More unsafe conditions from missing plate covers

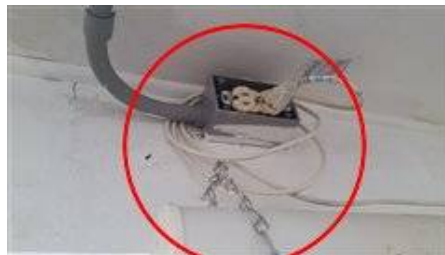
Photo 25-8
Cover plate missing in garage. Safety hazard
