Footprints Property Inspections, LLC

Client(s): John Smith and Susan Smith
Property address: 999 S. Some house Rd.
Copley Twp., OH 44321
Inspection date: Thursday, September 11, 2014

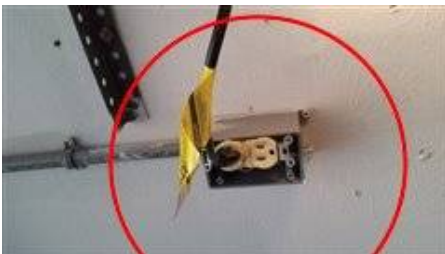
Photo 25-9
Cover plate missing in garage. Safety hazard

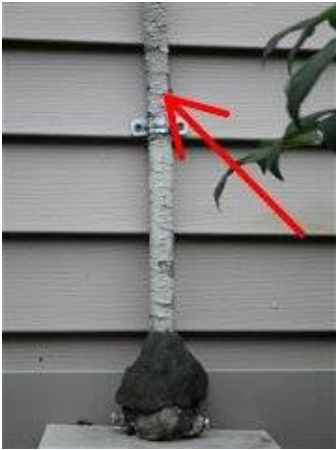
Main electrical service feed should be evaluated by First Energy on replacement of weathered feed line.

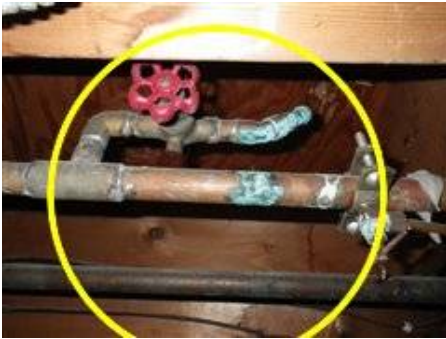
Pin holes and/or corrosion were visible on one or more copper water supply pipes. This can occur with acidic water, and from flux applied at fittings for soldering when the pipes were installed or repaired. Leaks can occur from pinholes and corrosion usually indicates past leaks. Recommend consulting with the local municipality and/or a qualified plumber about the local water supply's pH level, and researching solutions for this if necessary. Also recommend that a qualified plumber evaluate and replace water supply components if necessary.

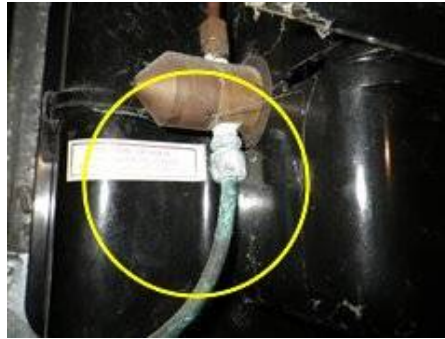
Corrosion found on plumbing pipe that appears to not be used and is capped off. Monitor for possible future leakage.

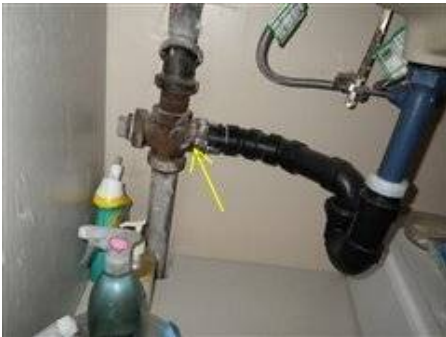
Humidifier line is corrosion and is in non-working order. Recommend line replacement and evaluate by HVAC tech. when servicing furnace.

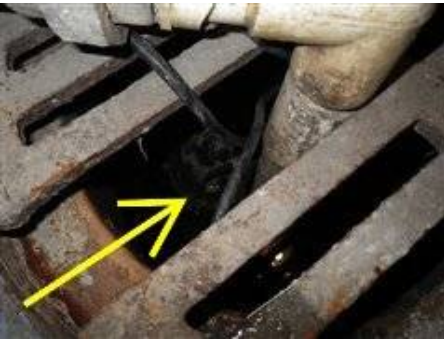
33) **i** A sump pump was installed in the basement. These are specialty systems and only a limited evaluation was performed as part of this inspection. The inspector does not determine the adequacy of sump pumps and their associated drainage systems. The presence of a sump pump may indicate that water routinely accumulates below or inside the structure. Recommend asking the property owner how often the sump pump operates and for how long at different times of the year. The client should be aware that the service life of most sump pumps is 5-7 years, and that the pump may need replacing soon depending on its age and how often it operates.

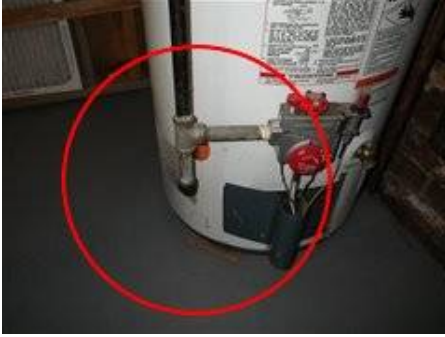
Water heater shut offs locations when needed.

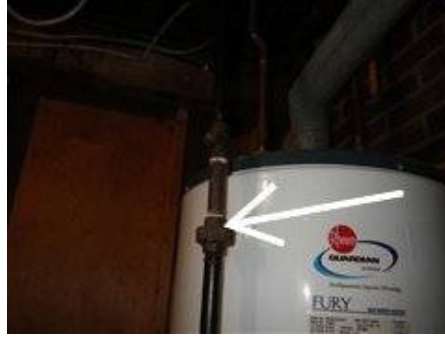
Galvanized piping used in place of approved black gas piping. Safety concerns and should be replaced.

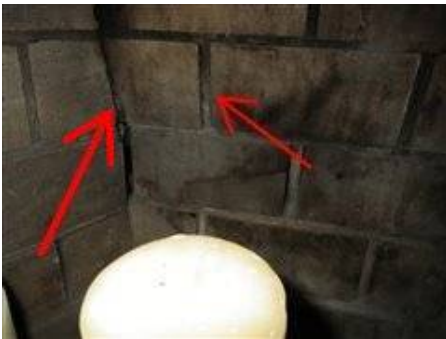
The fireplace's firebox was significantly deteriorated. For example, loose, cracked, pitted or broken firebricks, gaps between bricks and/or missing mortar. Heat from the fireplace may penetrate the firebox. This is a potential fire hazard. Recommend that a qualified contractor repair as necessary.

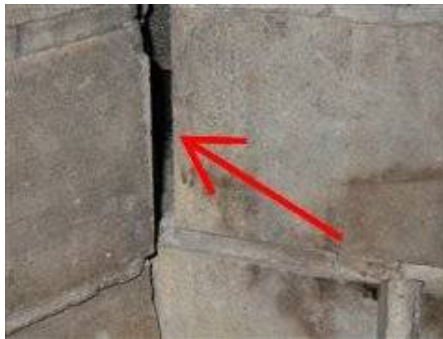
Wood burning fireplace has defective fire bricks with gaps. Fire brick lining needs tucked.

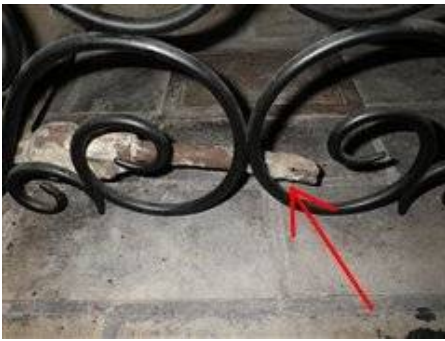
Gaps in fire box of wood burning fireplace - Unsafe condition.

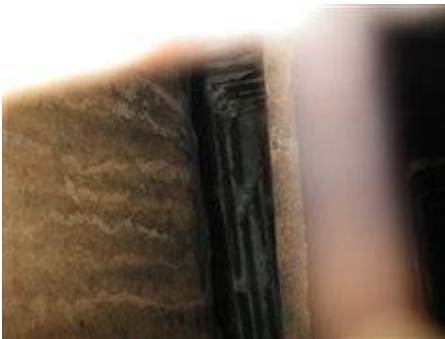
Have chimney inspected with fireplace firebox repaired. See offset of clay flue liners in picture.

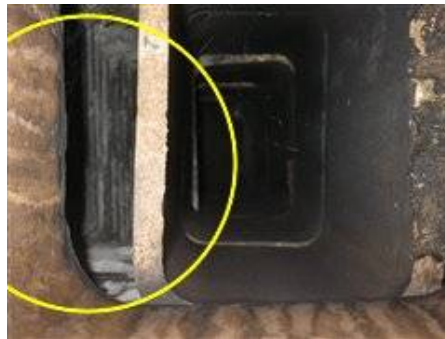
Clay flue liner in chimney is offset and needs evaluated by a qualified masonry contractor with chimney repair work.

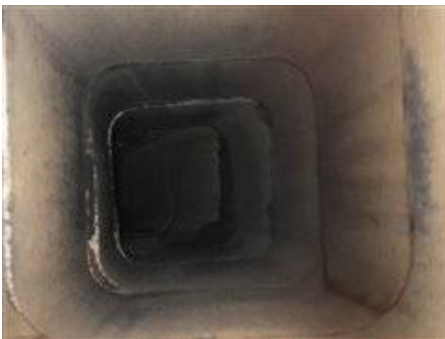
Clay flue liner in chimney is offset and needs evaluated by a qualified masonry contractor with chimney repair work.

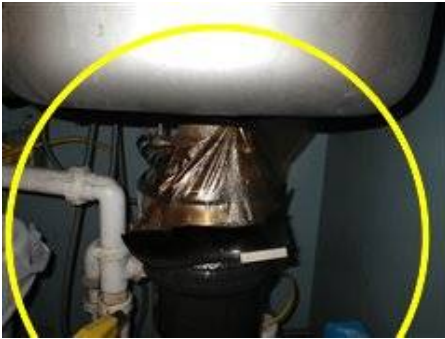
The under-sink food disposal was significantly corroded. Recommend that a qualified contractor repair or replace as necessary.

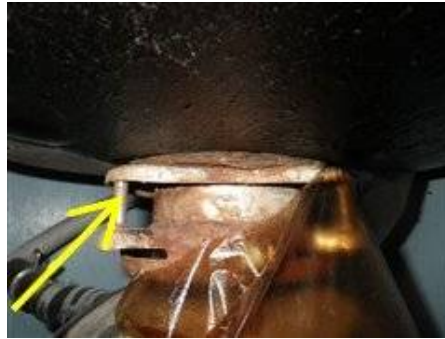
Garbage disposal is improperly sealed and shows previous leakage. See plastic tapped to mounting hardware.

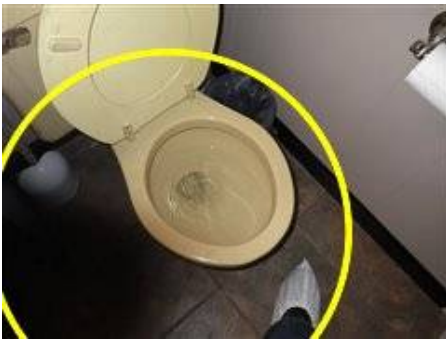
The toilet at location(s) #A was loose where it attached to the floor. Leaks can occur. Flooring, the sub-floor or areas below may get damaged. Sewer gases can enter living spaces. Recommend that a qualified contractor remove the toilet(s) for further evaluation and repair if necessary. A new wax ring should be installed and toilet(s) should be securely anchored to the floor to prevent movement and leaking.

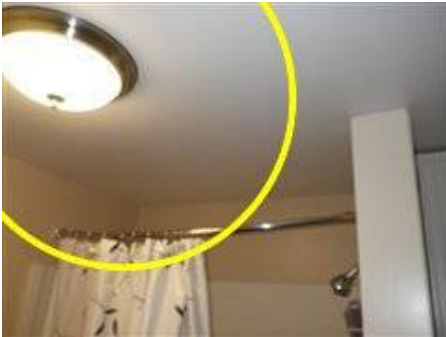
The bathroom with a shower or bathtub at location(s) #B didn't have an exhaust fan installed. Moisture can accumulate and result in mold, bacteria or fungal growth. Even if the bathroom has a window that opens, it may not provide adequate ventilation, especially during cold weather when windows are closed or when wind blows air into the bathroom. Recommend that a qualified contractor install exhaust fans per standard building practices where missing in bathrooms with showers or bathtubs.

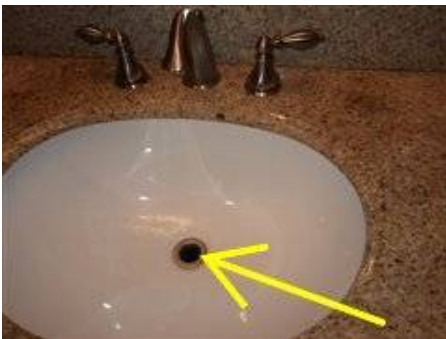
Sink stopper missing in bathroom "A" lower level.

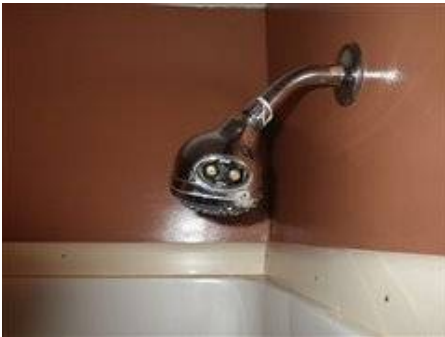
Shower head missing side cover.

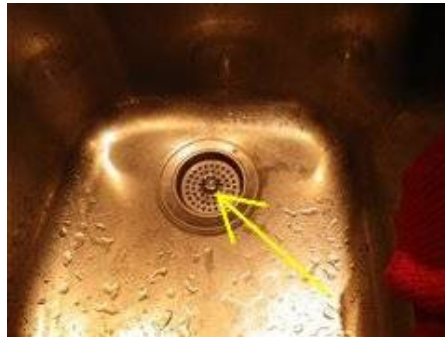
Shower head missing cover plate.

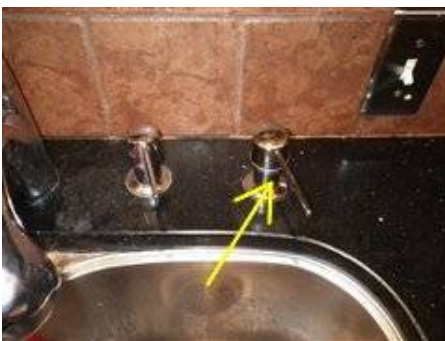
Sink stopper is defective and doesn't seem to hold water when tested.

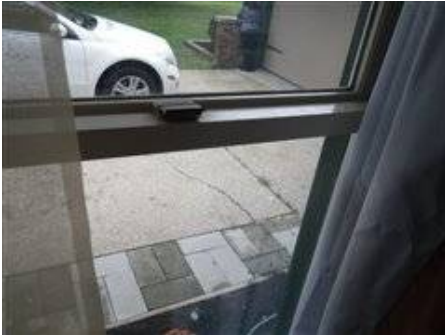
Photo 50-1
Craftline Double hung window was stuck and did not open when tried.

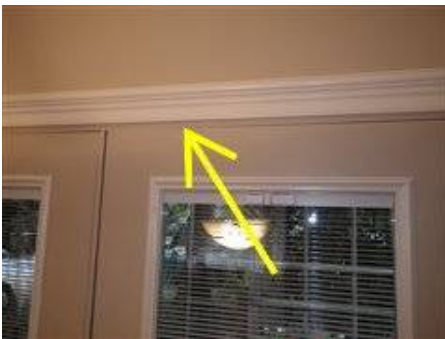
Photo 51-1
Double door needs re-aligned.
Recommend trying adjust with 2 1/2" to 3

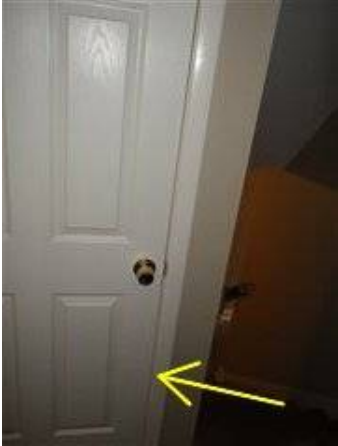
Also a couple of the doors needed bottoms trimmed off to prevent carpet damage.

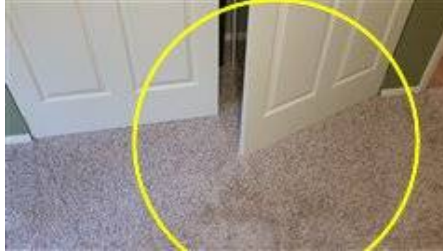
Door needs side shaved or sanded as it stick in frame.

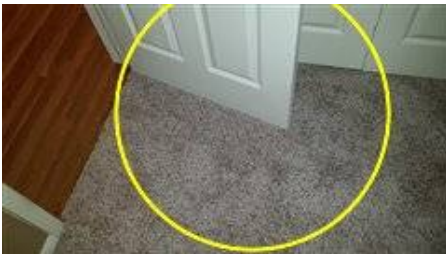
Doors drag on newer carpet and recommend trimming down to prevent damage to carpet.

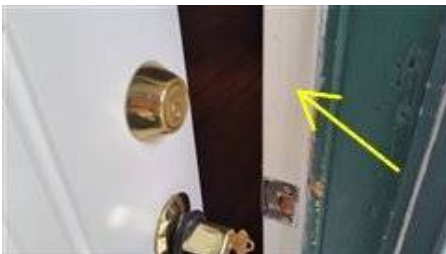
Front entry door deadbolt no properly installed on latch bolt. (not cut of frame)

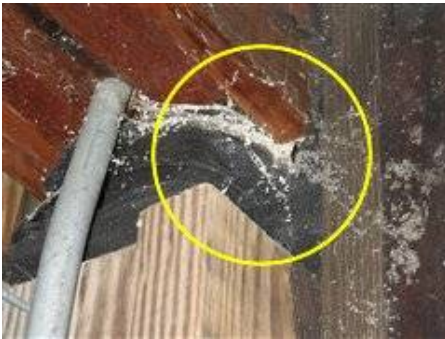
Photo 55-1
Carpenter ant evidence on decorative center beam - recommend treatment for both carpenter bees and carpenter ants.

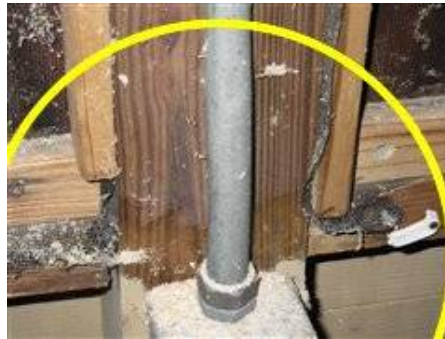
Photo 55-2
Wood destroying insect damage evidence.

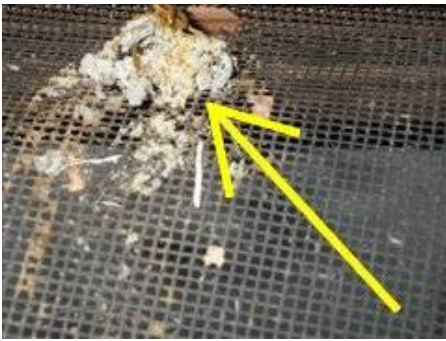
Photo 56-1
Evidence of wood destroying Carpenter bees on patio privacy wall/screening.

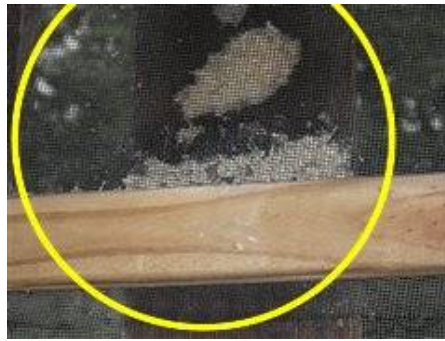
Photo 56-2
Evidence of carpenter bee damage. Recommend plugging holes with a butyl caulk to prevent reuse next season.

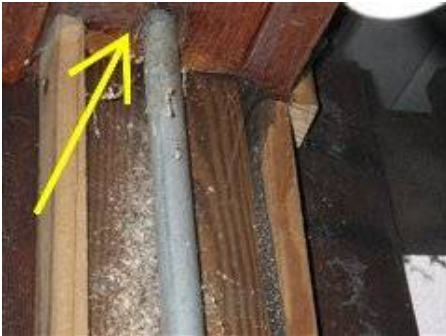
Photo 56-3
Wood destroying insect damage evidence.

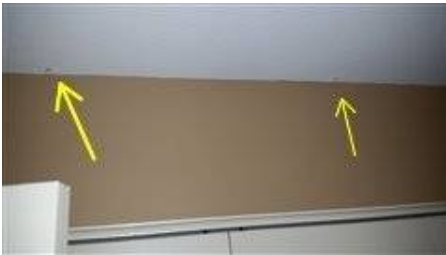
Photo X-1
Nails popped - remove and patch

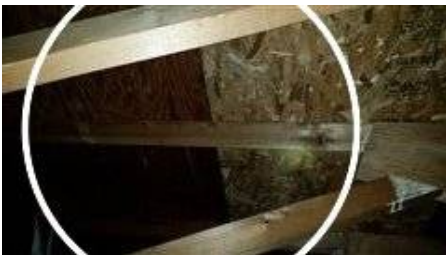
Photo X-3
Previous repaired roof sheeting
